Laboratory Hood Hydrogen Fire Incident

Bob Zalosh¹ and Nick Barilo²

Presented at the 25th Hydrogen Safety Panel Meeting, New Orleans, LA, April 2019

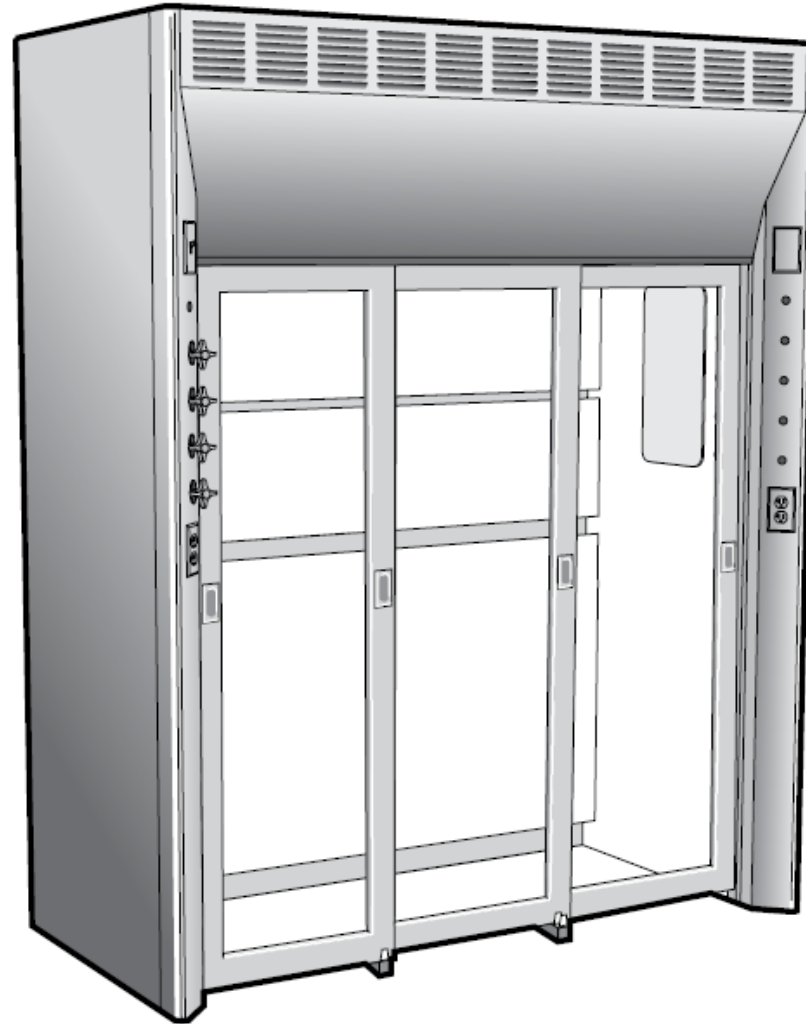
Walk-In Fume Hood

Incident Hood had 4 sliding doors on each side; exhaust ventilation duct on ceiling.

Hood
Dimensions:
12' Long x 5' wide
x 7.5' High

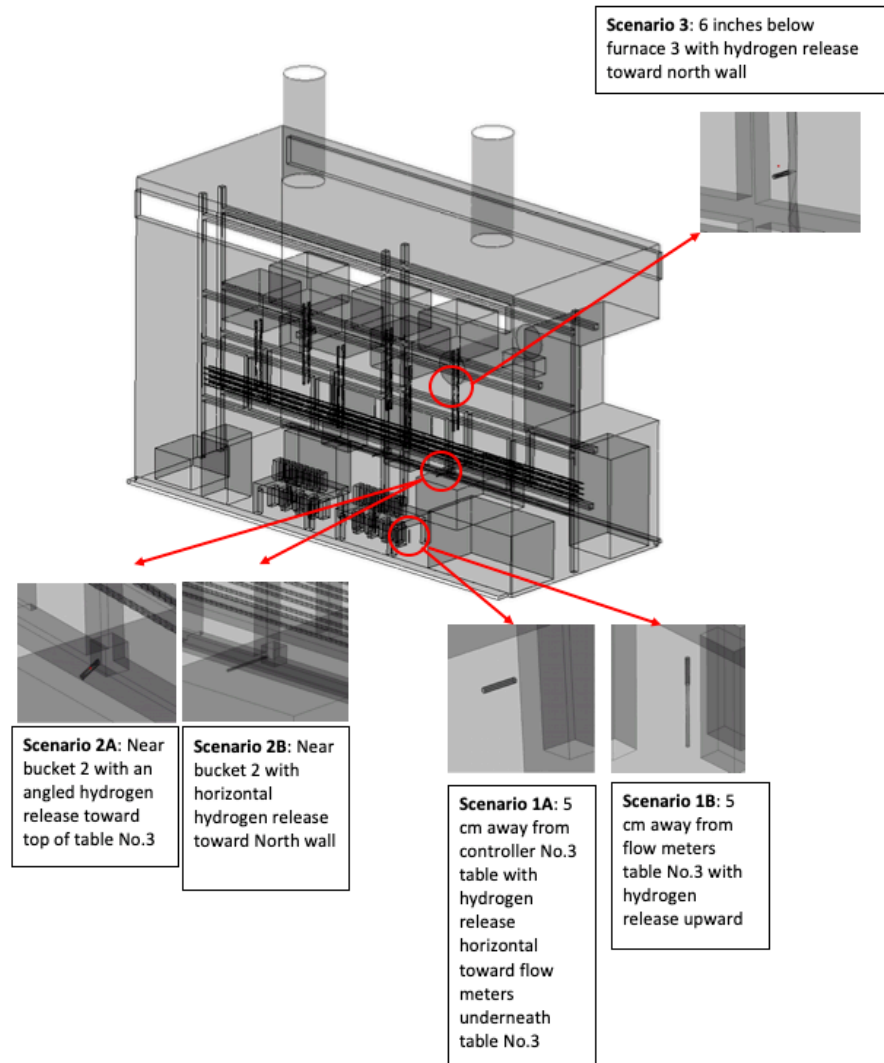
Hydrogen Dispersion Calculations: Release Scenarios

- Calculations conducted with Fluent CFD Code
- 18 cfm hydrogen release in 5 different locations and directions
- Normal hood exhaust ventilation: 500 cfm through each of two exhaust ducts.
- Makeup air inflow under and above hood doors.
- CFD Output is hydrogen concentration distribution and volume of flammable region with H₂ concentrations > 4% and > 6%
